INSTRUMENTATION AND FLIGHT
PERFORMANCE OF HCO HIGH
RESOLUTION WAVELENGTH
SPECTROMETER

NASA AEROBEE 4.185 US

by
J. Crawford
W. H. Parkinson

May 1969

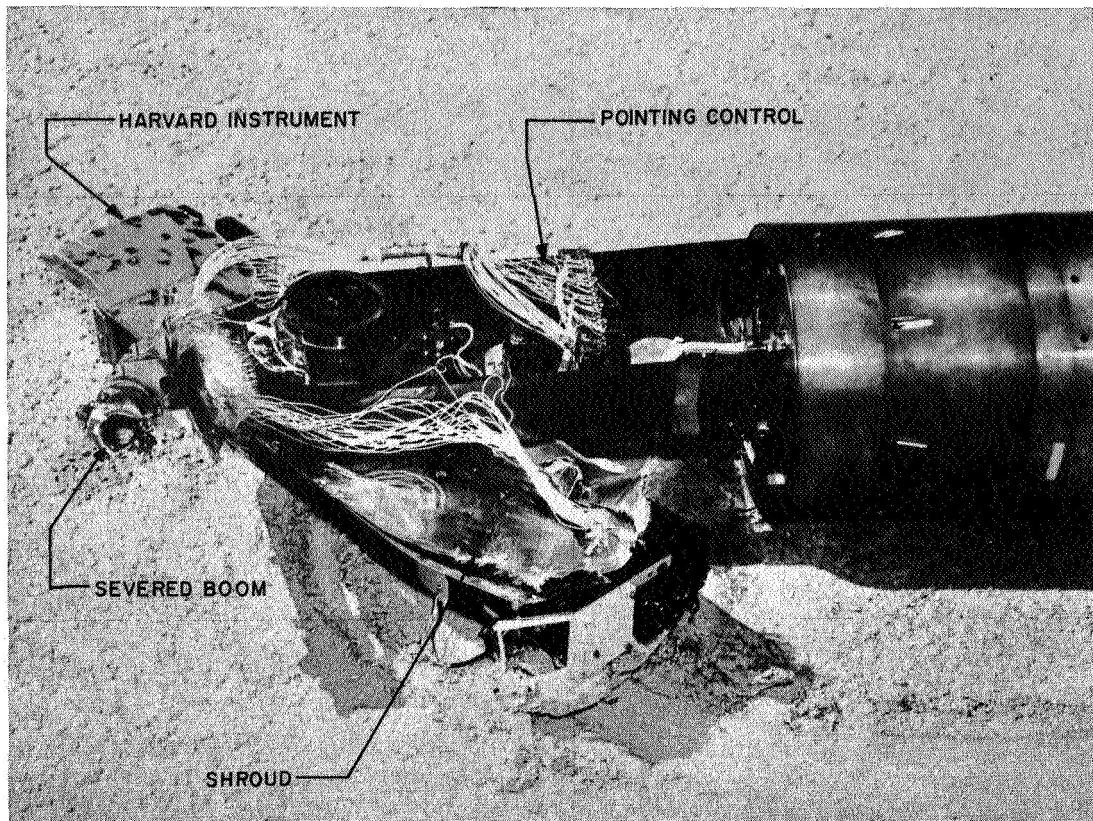
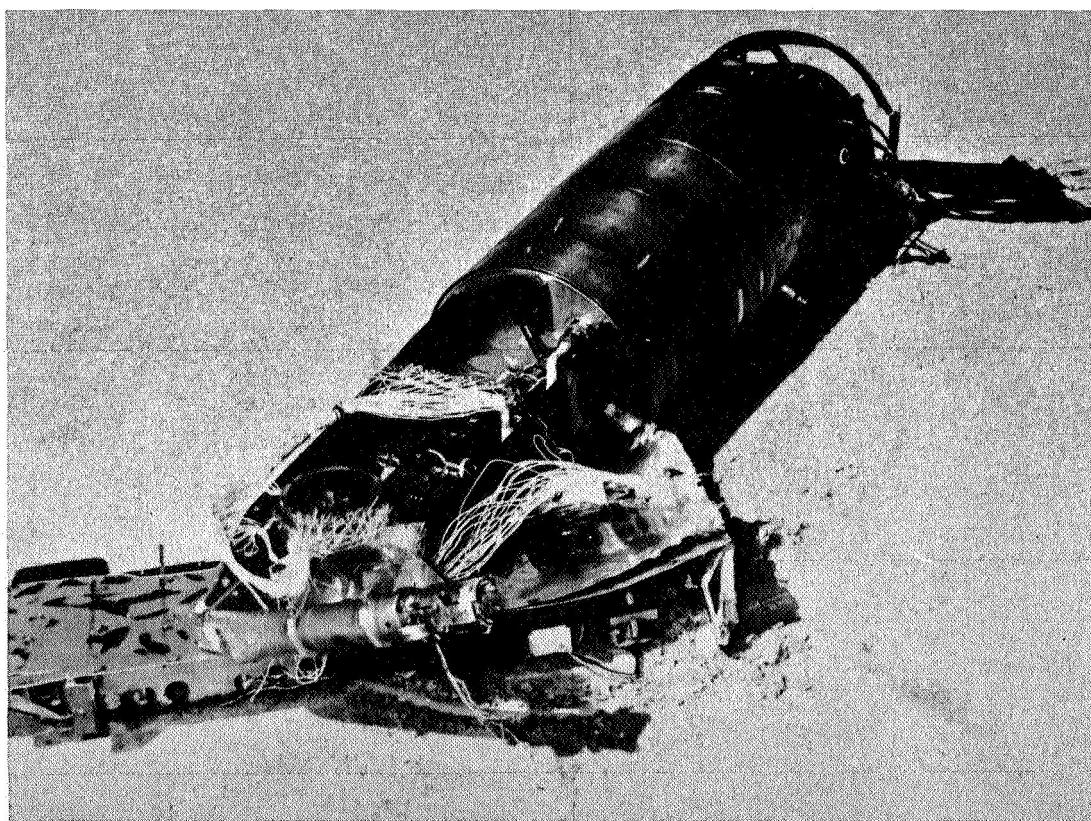
FIGURE I -INSTRUMENT AT RECOVERY

The instrument had broken out of the stowed position during reentry, probably on parachute deployment. Because of this, and because the nose cone did not come down, the instrument was subjected to surface heating, buffeting, and desert contamination. The fiberglass thermal shield was burned and ripped away, but the rest of the instrument exhibited very little damage when it was brought back to the Navy Headquarters building after the shot. The instrument will be refurbished and relaunched. (Figure 1 shows two views of the instrument at the recovery site.)
